QUANG NGAI RURAL DEVELOPMENT PROGRAM (RUDEP) - PHASE 2

Infrastructure 2003-2004

Date: 6 October 2004
Reference: 42443858
Status: Final

Annex 1: Pictures of the Projects

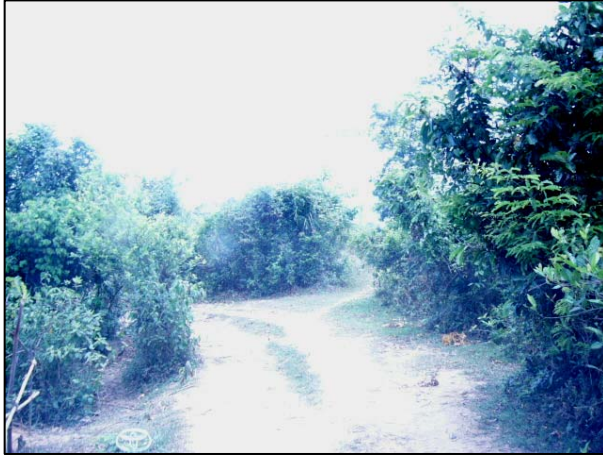
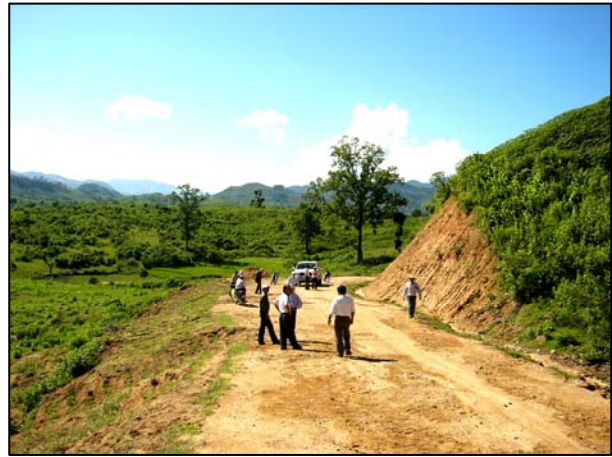
LANG LANH ROAD

The design of the road was not done properly because the budget was limited but the road is too long.

The designer didn't survey the geology of that area. There are some sections are not stable especially in the rain.

A culvert was not allocated at suitable places so it may work ineffectively.

There are two places need the spillways. The slope of the road is too high so the side drains may be not stable, even the road surface. This road needs to be improved.

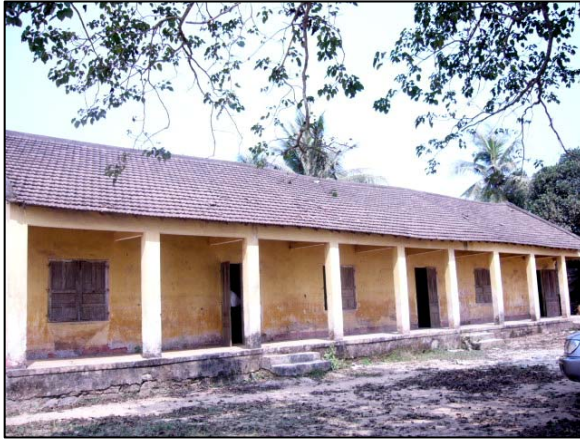
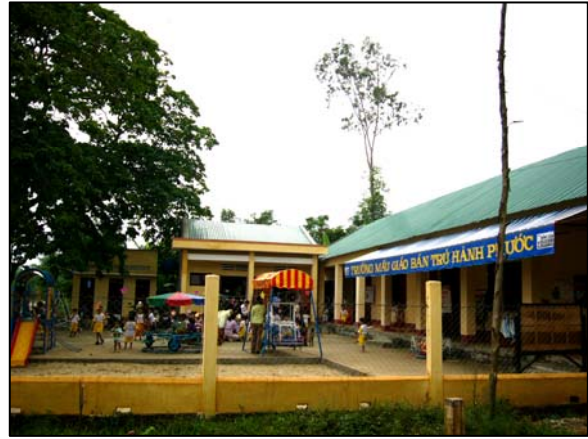
HOA VINH FULL DAY KINDERGARTEN

This is an upgrade project so there was some additional works needed to be done. The designer didn't predict the items needed to be repaired properly. It took more time for the consideration of additional work.

The CPC didn't check the site carefully; there were some troubles in allocating the kitchen and the toilet for the new kindergarten. In order to fix the problem, the kitchen and the toilet were not constructed at a convenient place. The contractor didn't have enough capacity to finish the work on time.

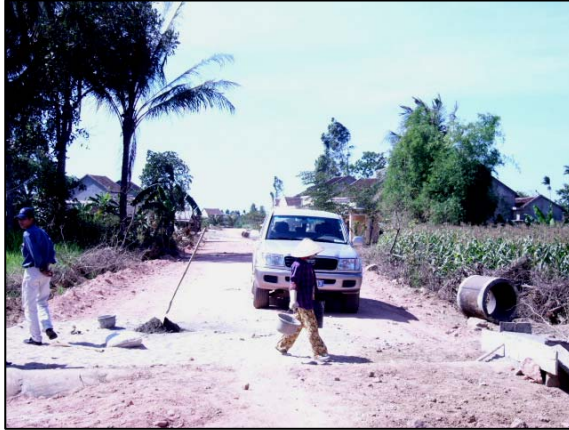
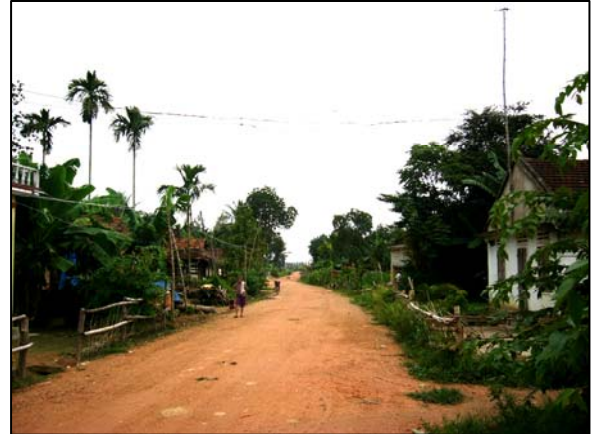
A CHI DONG – A CHI TAY ROAD

Because there was no compensation for the land used for road construction, the road was not constructed properly in some sections. Some local people don't want to lose their land, so the side drains are not wide enough.

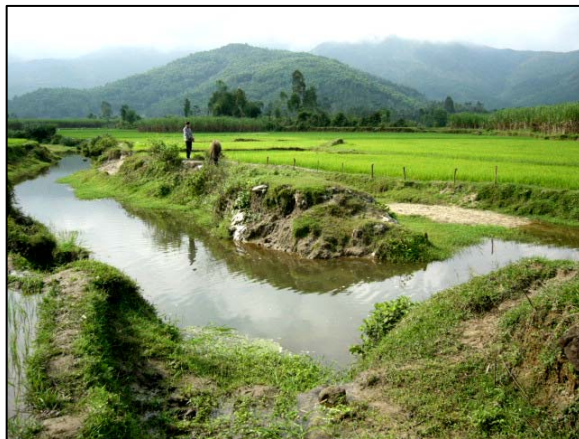
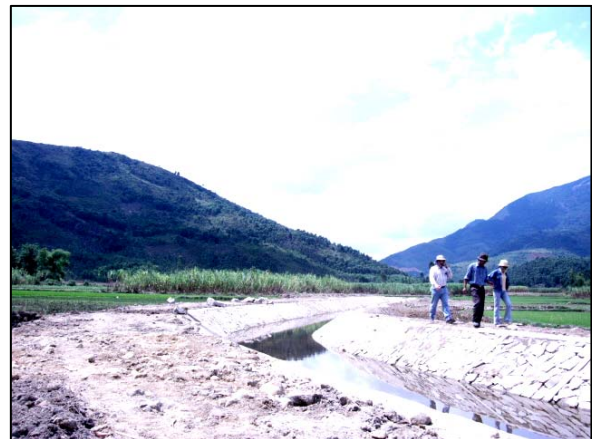
CAU PHEN IRRIGATION CANAL

Anyway, the design was not sufficient. There was no access way for cross drainage. And the outlet of water gate is not reasonable.

So this project is needed to be improved the following year.

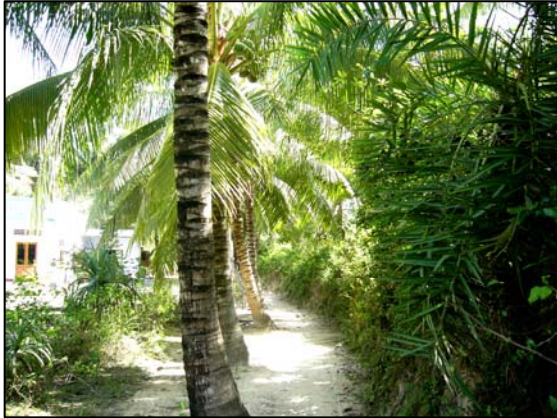
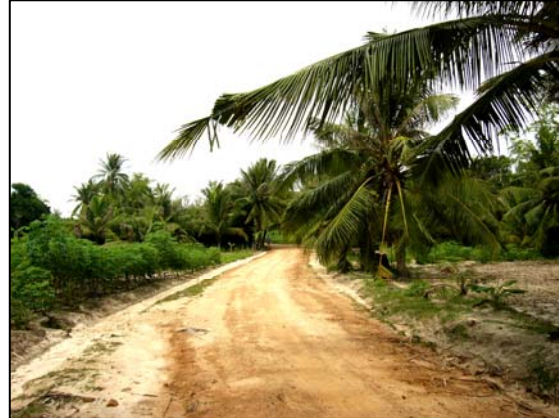
DA DEN ROAD

The road was not designed to be protected by grass for the verge and the embankment, especially at both ends of culverts.

The design was not checked properly by District Industry Department, the length of the deepest culvert is not suitable to the road. So the road above the culvert is easily eroded in the wet season.
